# Water Quality Below Glen Canyon Dam and Reaeration of Releases

**Bill Vernieu**

Technical Work Group Meeting

November 30, 2005

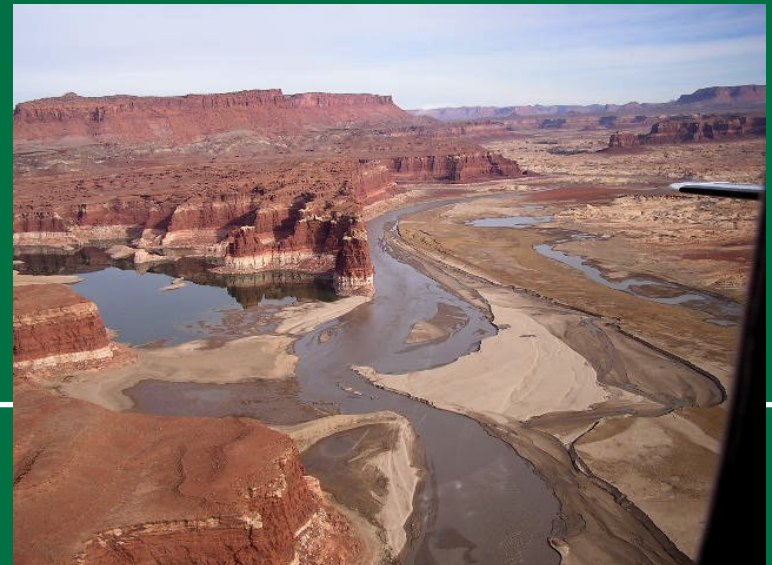
# Lake Powell Hydrology

- Surface elevation - 3555 ft on April 8, 2005
- Lowest elevation since May 1969
- 38 % of total capacity
- 145 ft below full pool elevation of 3700 ft
- Large amount of deltaic sediment exposed in inflow areas

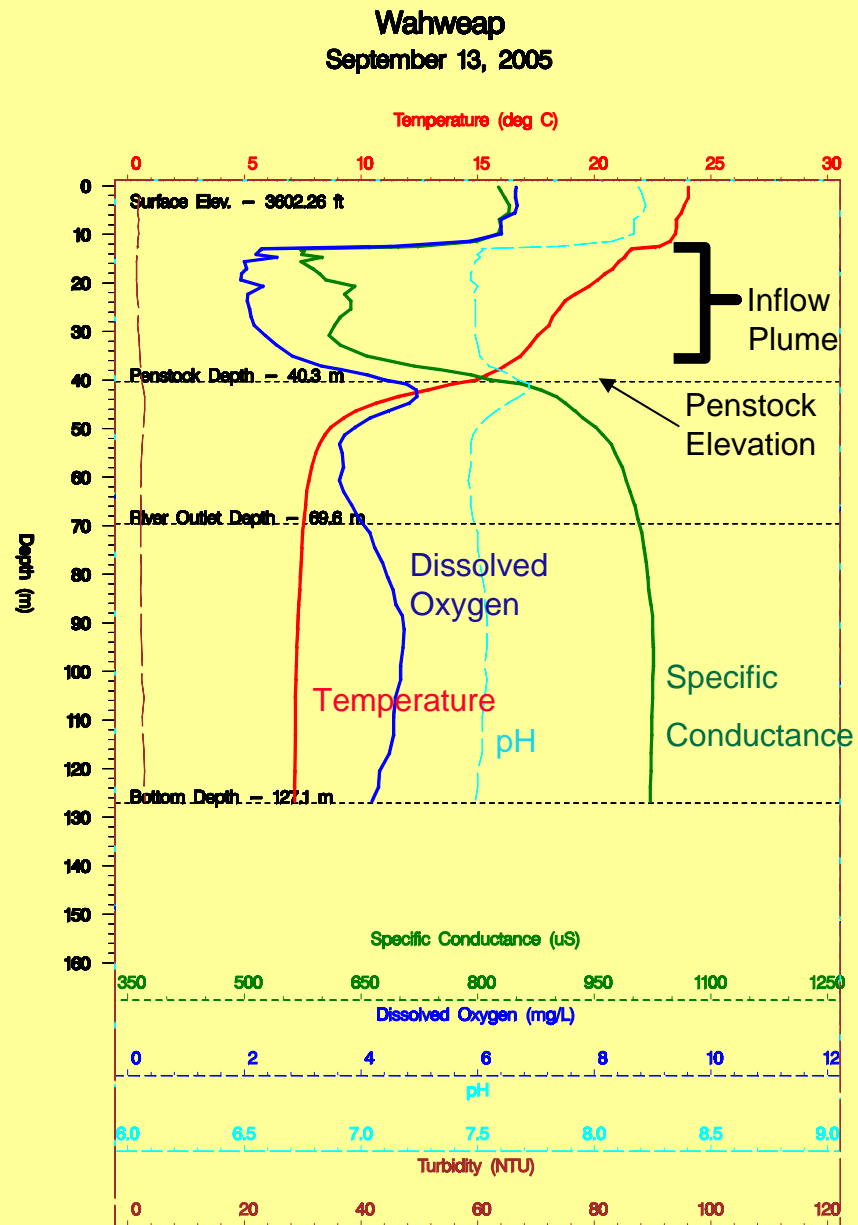
# Forebay Water Quality

September 13, 2005

Inflow plume beginning to affect  
Glen Canyon Dam releases

- Inflow plume
  - 13m-38m
  - Minimum D.O. 1.9 mg/L
- Glen Canyon Dam Release
  - T - 14.5 °C (58 °F)
  - D.O. - 4.5 mg/L (51 %)

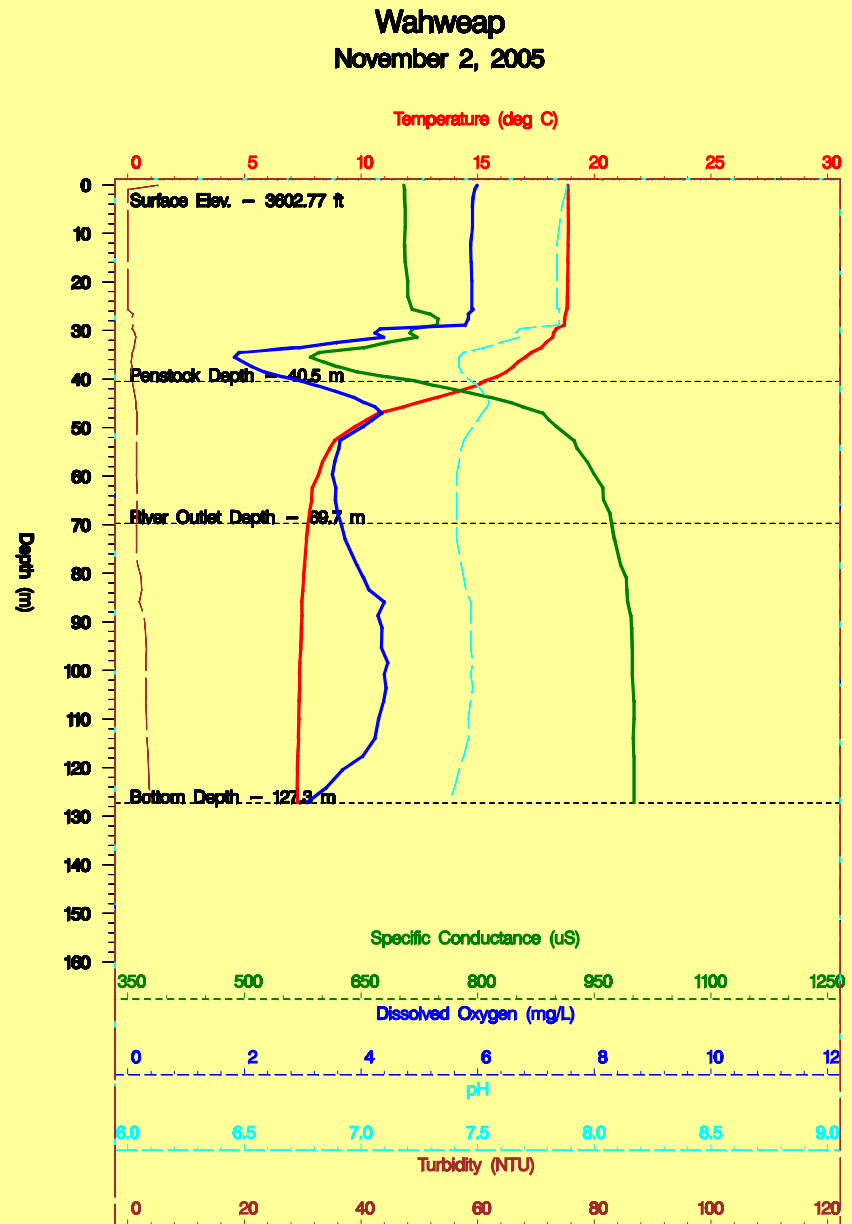
# Forebay Water Quality

November 2, 2005

Surface of reservoir mixing

Release WQ further affected

- Inflow plume
  - 28m-40m
  - Minimum D.O. 1.7 mg/L
- Glen Canyon Dam Release
  - T - 15.8 °C (58 °F)
  - D.O. - 3.6 mg/L (41 %)

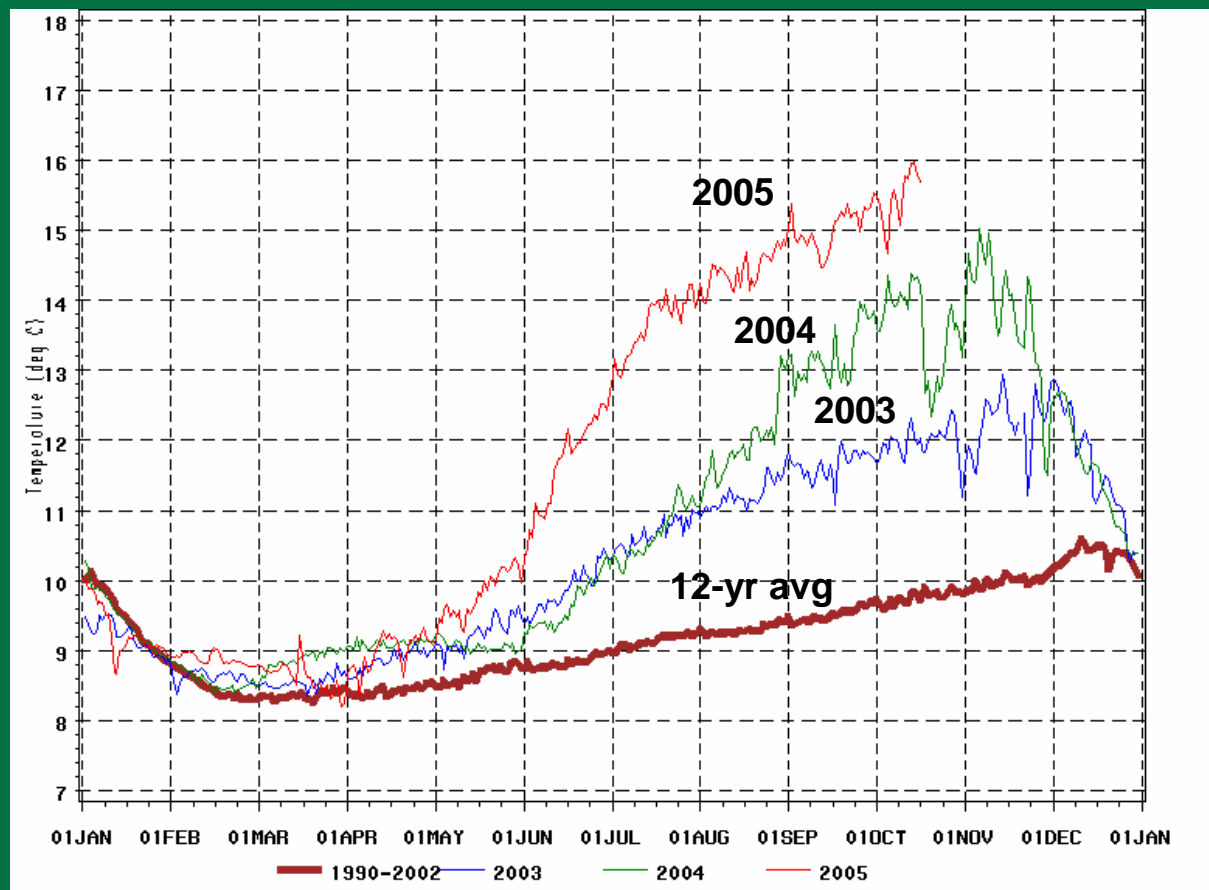
# Glen Canyon Dam Release Temperature

- Warmest releases since 1971
- 16°C (61°F) on October 8, 2005
- 6°C above 12-yr average

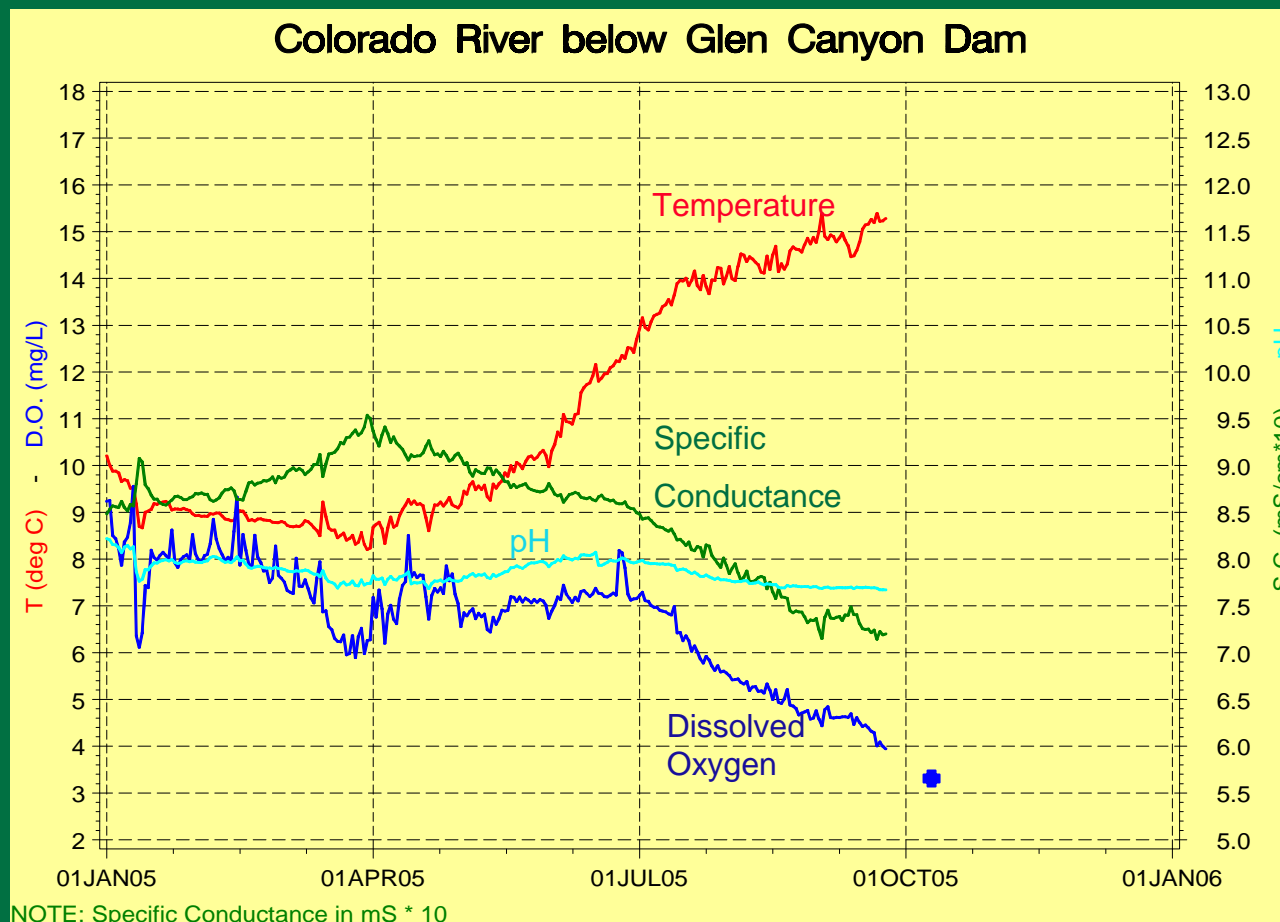
# Glen Canyon Dam Releases 2005

Mean daily values

- Lowest dissolved oxygen on record (since 1990)
- 4.0 mg/L on September 25, 2005
- 3.3 mg/L on October 8, 2005 from draft tubes

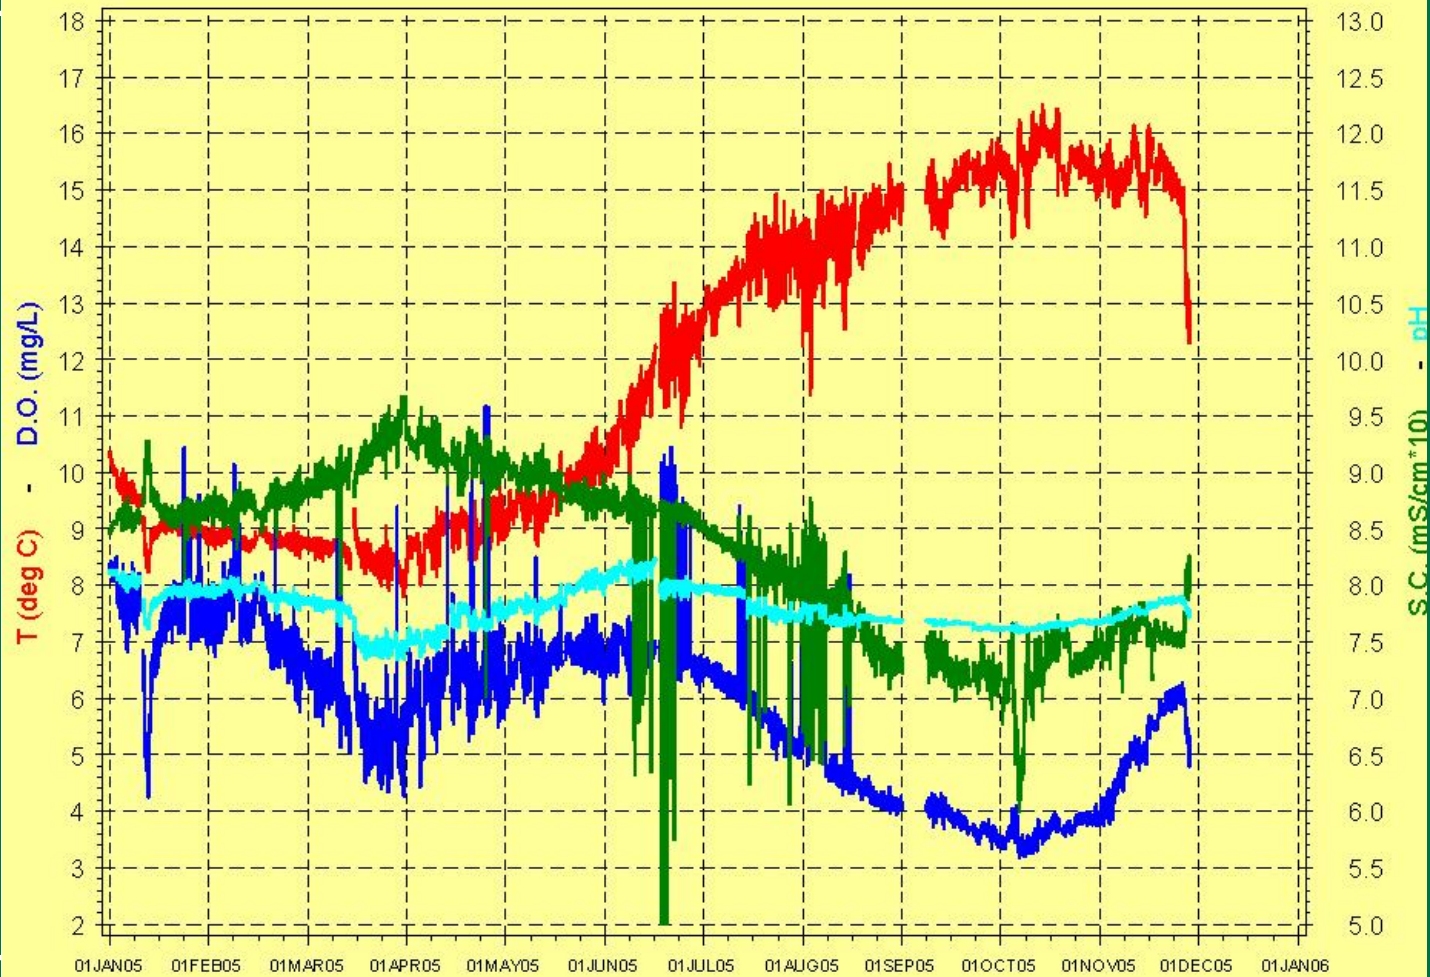
## Glen Canyon Dam Draft Tube

NOTE: Specific Conductance in mS \* 10

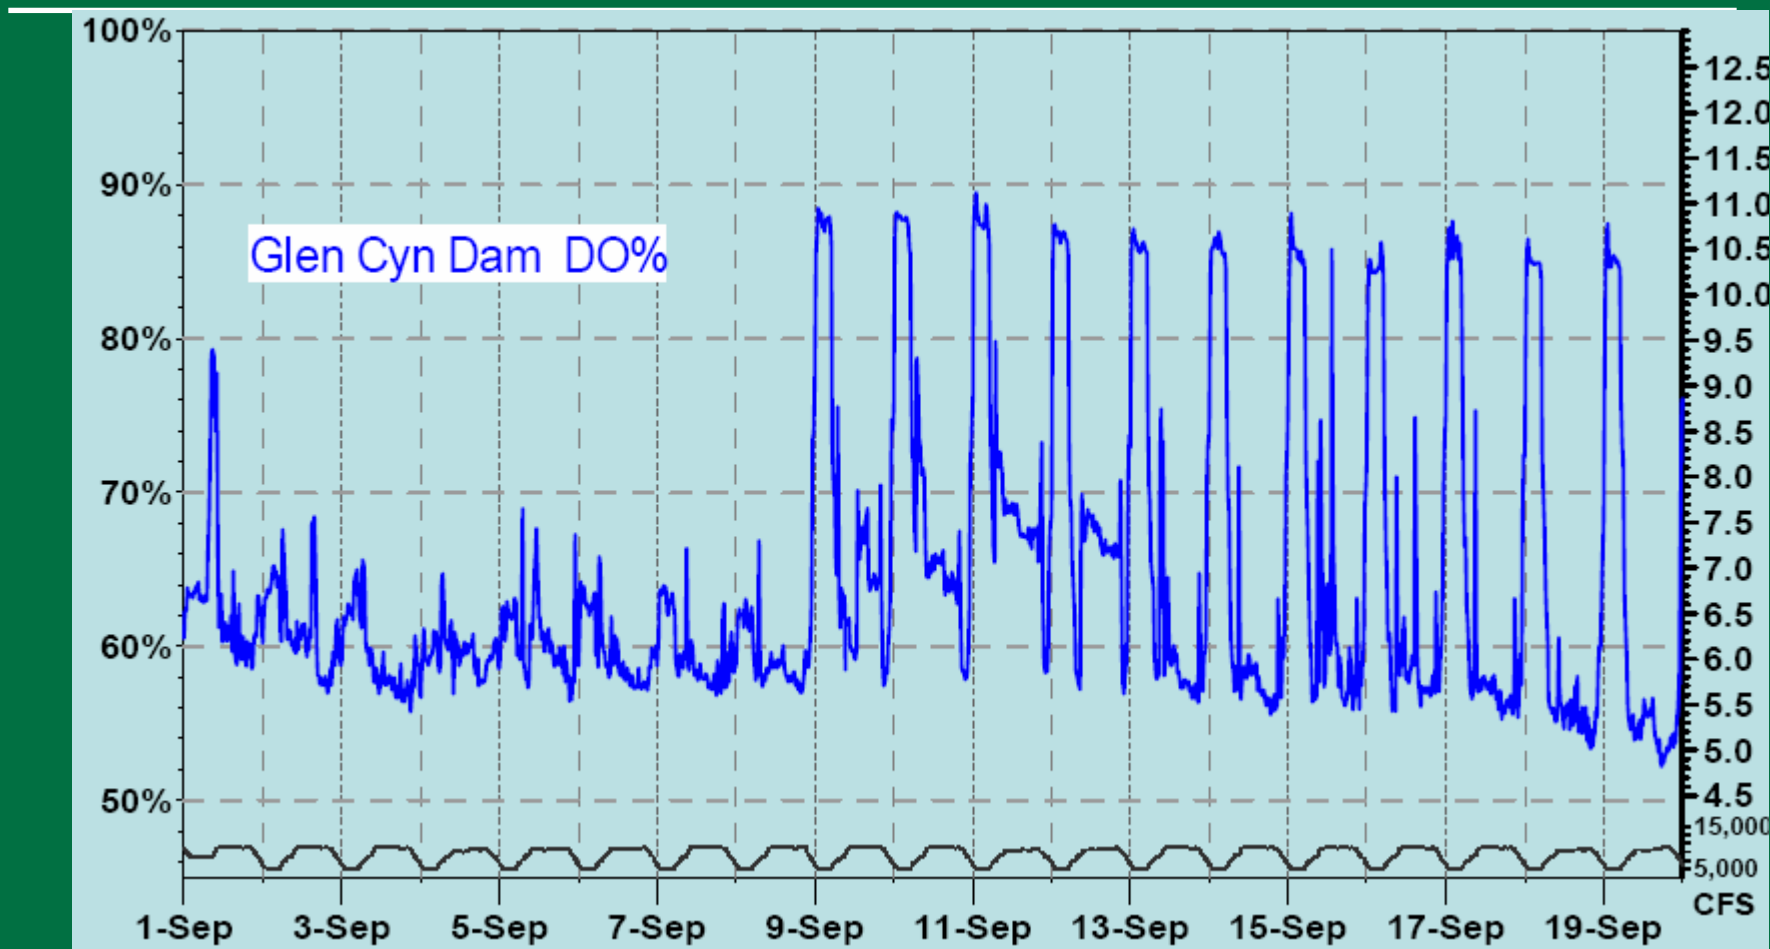
# Nighttime Reaeration Spikes - 2005

- Past monitoring data has shown elevated dissolved oxygen levels in GCD tailwater during nighttime hours (~11 pm to ~7 am)
  - These spikes appear to be associated with low discharge levels from individual turbines
  - Turbine discharges resulting in maximum reaeration of releases may cause inefficient power generation and damage to turbines
  - Reclamation has experimented with various operational regimes during recent experimental flow period to achieve optimal balance
-

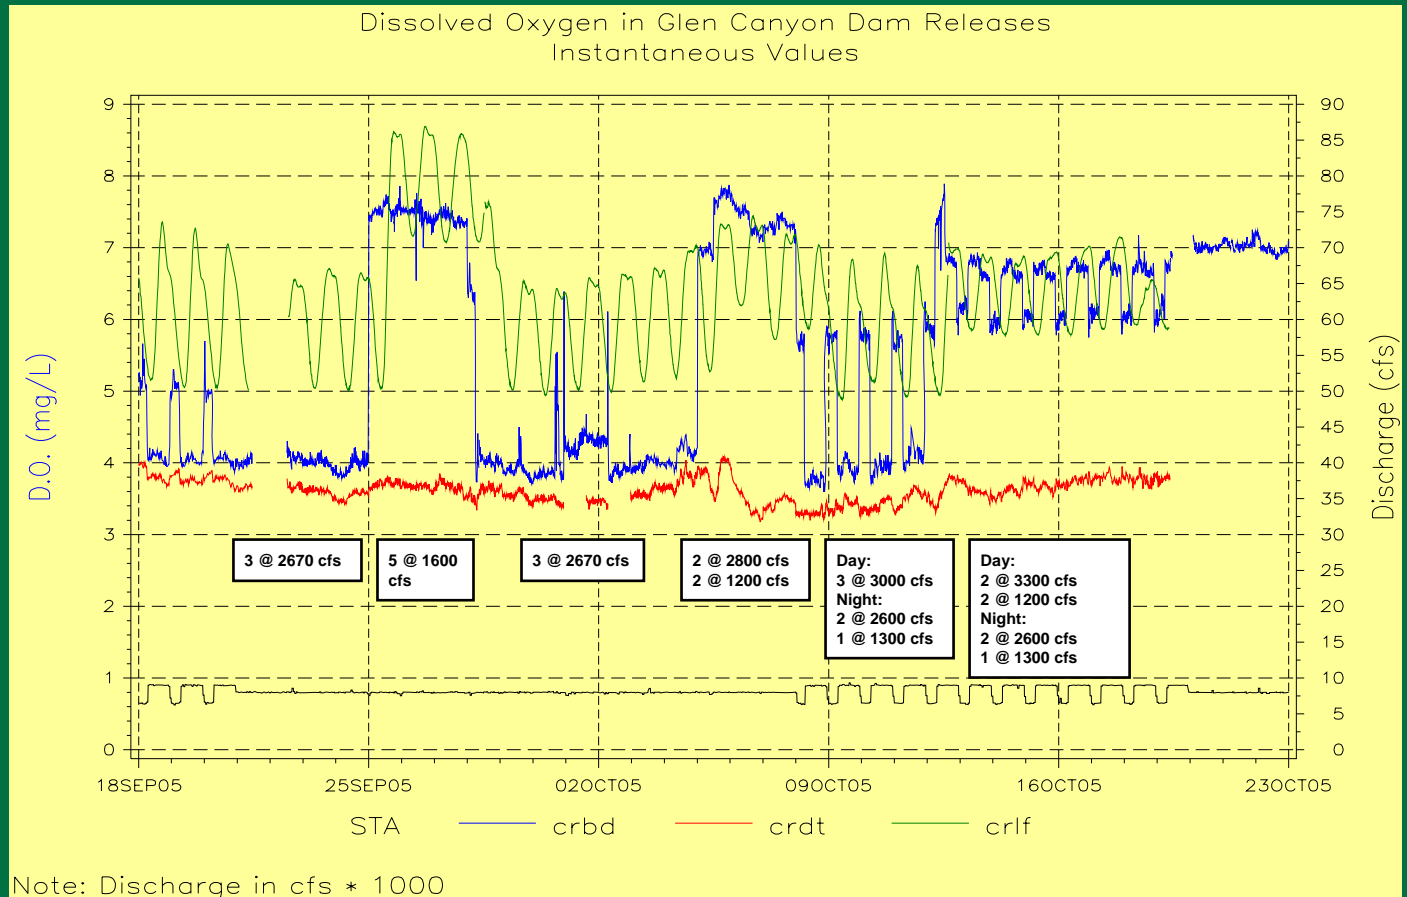
# Reaeration Experiment

Long-term monitoring at three locations:

- CRDT (red)  
GCD Draft Tube
- CRBD (blue)  
GCD tailwater
- CRLF (green)  
Lees Ferry

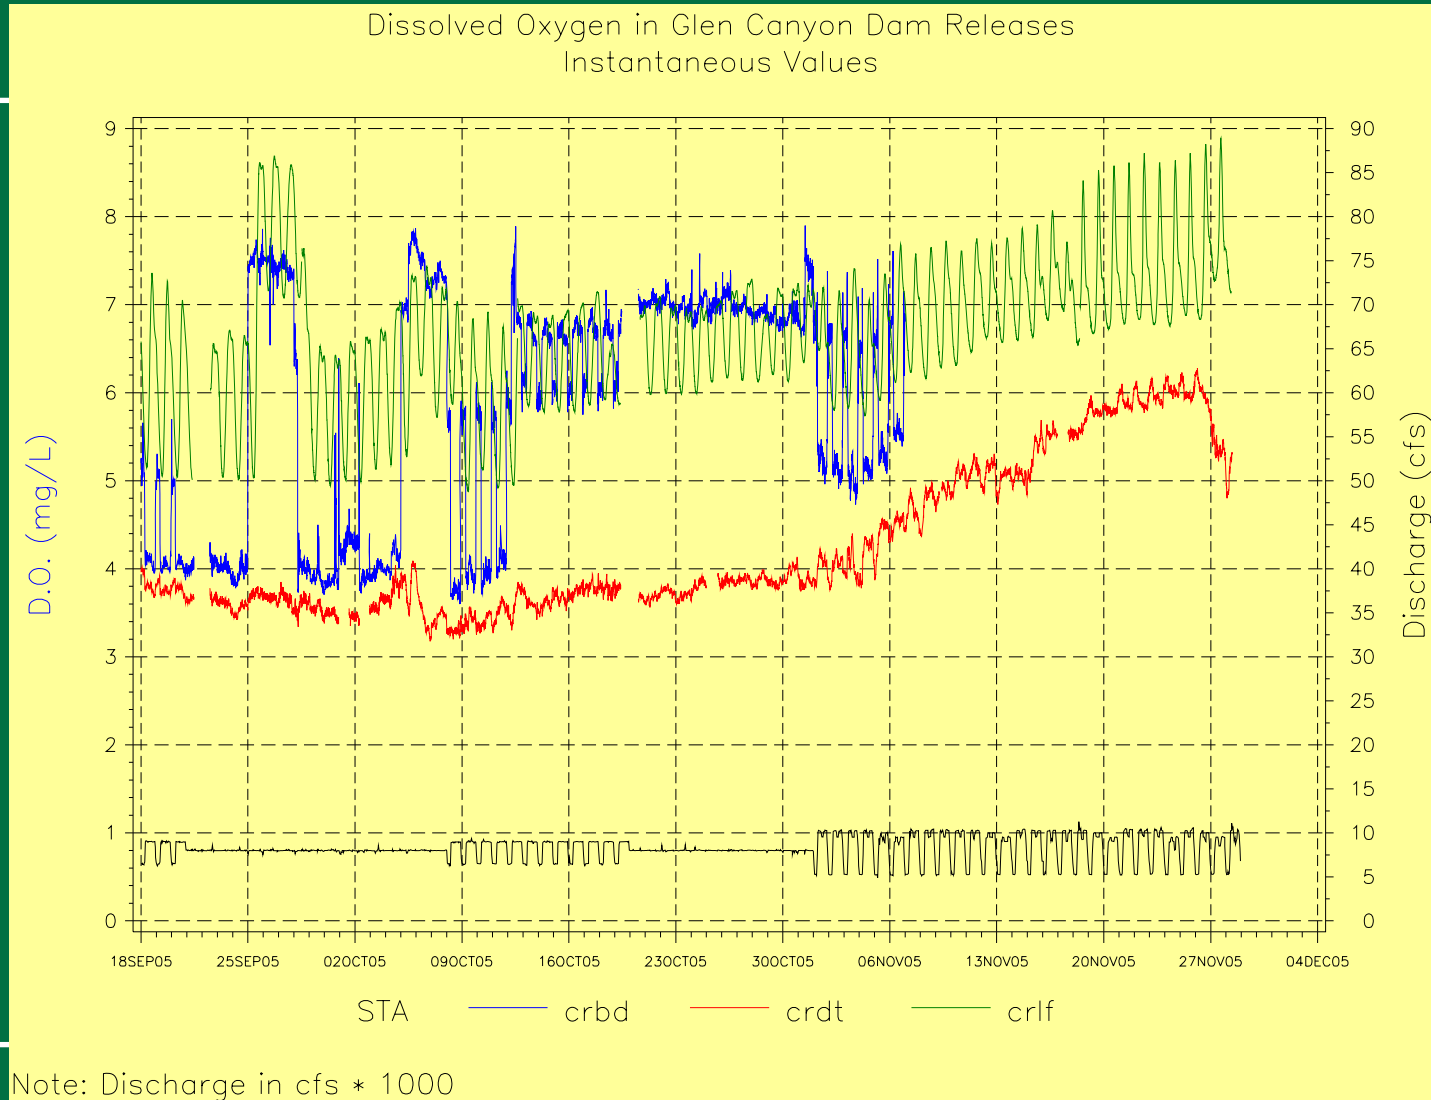
# Recent Release Water Quality

- D.O. in tailwater (blue line) reduced with cessation of experimental flows
- Displaying nighttime D.O. spikes
- Increase in draft tube D.O. (red line) indicating reservoir mixing
